DOT/FAA/AR-99/57

Fuselage Burnthrough Protection for Increased Postcrash Occupant Survivability: Safety Benefit Analysis Based on Past Accidents

September 1999

Final Report

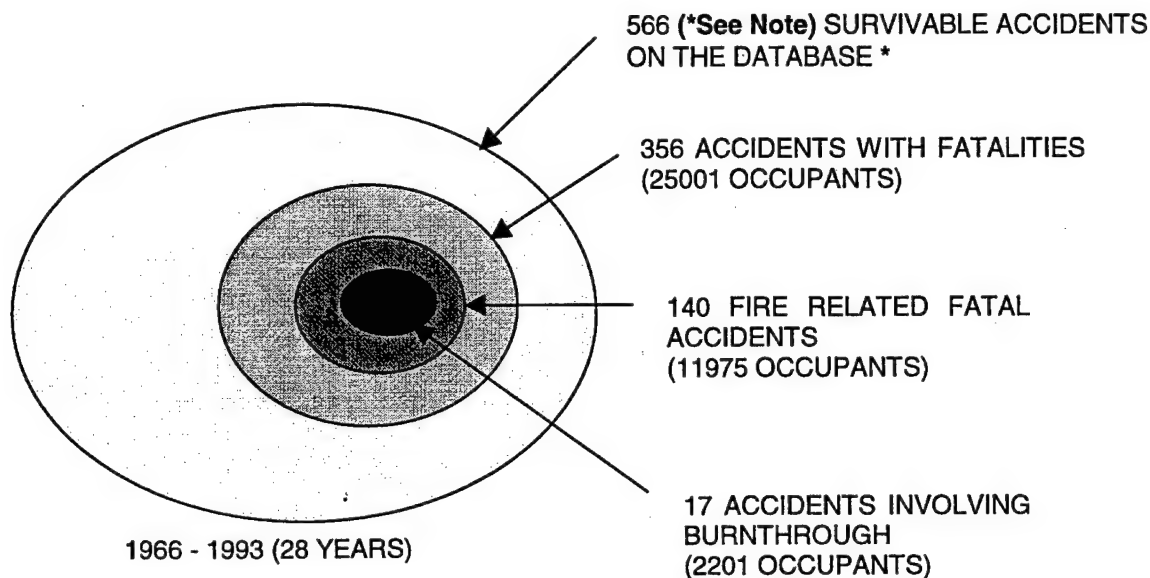
FIGURE 1. RELATION OF SELECTED DATA TO WHOLE DATABASE

Seventeen accidents were identified as listed in table 1. The relationship between this subset and all fatal accidents on the database is shown in figure 1.

Note: This does not represent all survivable accidents over the time period considered.

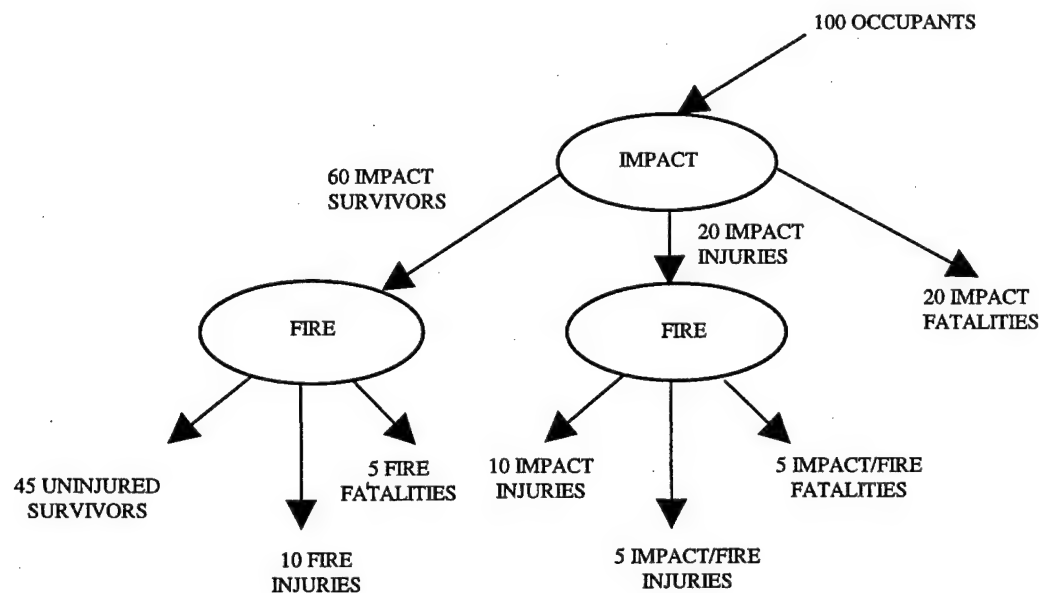
FIGURE 2. EXAMPLE SURVIVABILITY CHAIN

An example of the model and the effects of improvement in injuries and fatalities resulting from changes to fuselage fire hardening are shown in figure 2.

- 30 fatalities, 20 as a result of the impact and 10 as a result of the fire (5 of whom sustained nonfatal injuries from the impact).

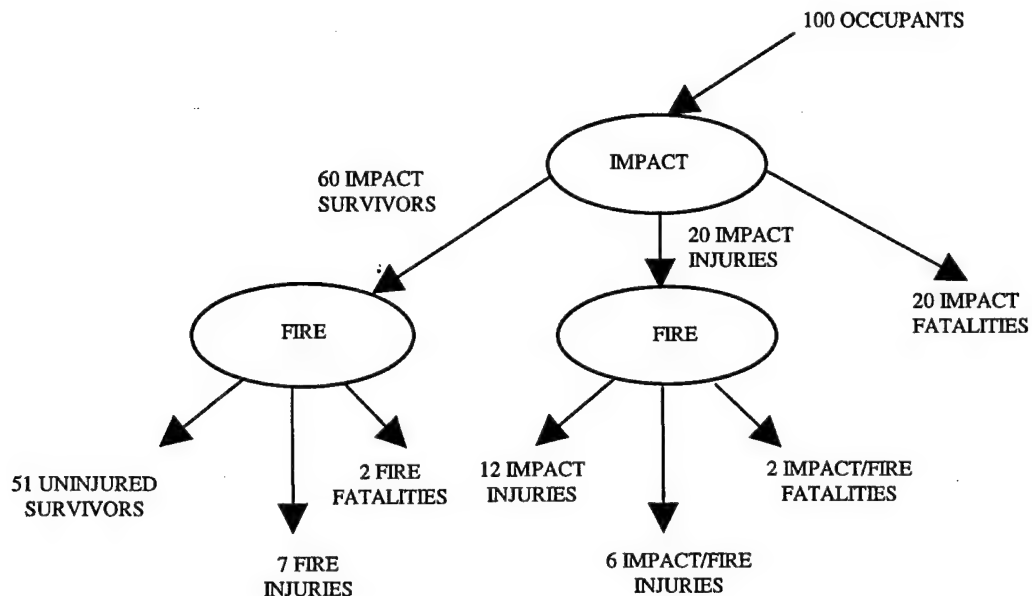
FIGURE 3. EXAMPLE OF SURVIVABILITY CHAIN SHOWING POSSIBLE IMPROVEMENTS IN SURVIVABILITY AS A RESULT OF FUSELAGE FIRE HARDENING

If improvements were made to fuselage fire hardening, such that it was assessed there were now only 2 fatalities and 6 seriously injured of the 20 impact injured occupants and only 2 fatalities and 7 seriously injured of the 60 impact survivors, then the survivability chain becomes as shown in figure 3.

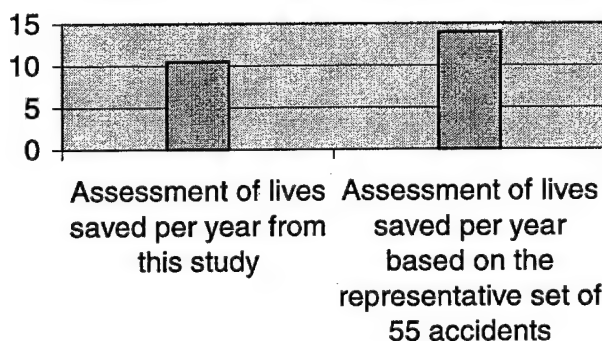
FIGURE 9. BAR CHART SHOWING COMPARISON BETWEEN THE RESULTS FROM THIS STUDY AND THAT DERIVED FROM THE REPRESENTATIVE SET

Assessment of Lives Saved per Year From This Study	Assessment of Lives Saved per Year Based on the Representative Set of 55 Accidents
10.5	14

The similarity of the two values suggests that the prediction of benefit, taking into account the accidents for which data are not available, is reasonably accurate.

A comparison has also been made between the predictions of benefit from this analysis and those derived from a study of a representative set of survivable accidents as described in section 5.3.2. The results compare reasonably well as shown in figure 9.

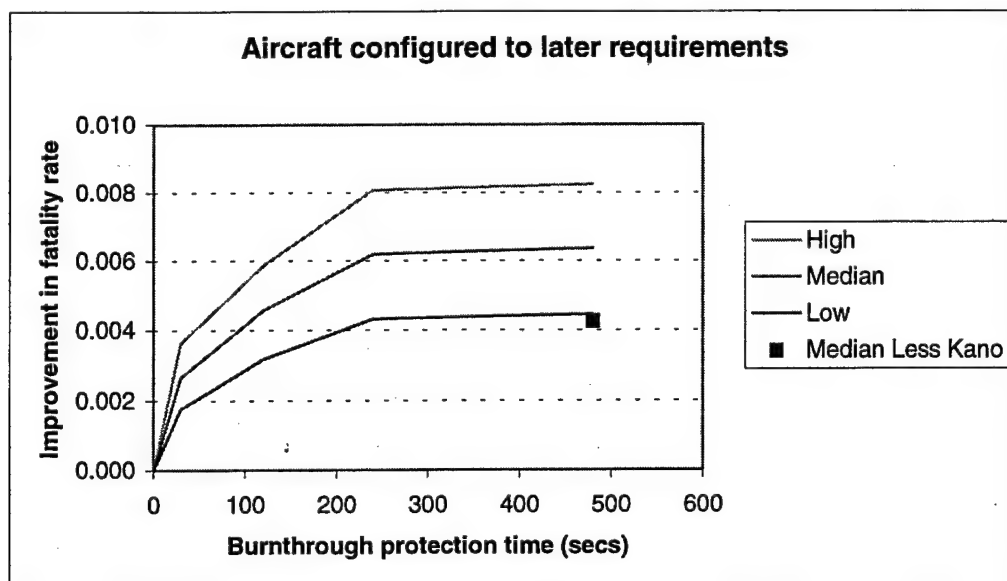
FIGURE 10. REDUCTION IN MEDIAN IMPROVEMENT WITH HIGHEST CONTRIBUTING ACCIDENT REMOVED

The accident, which contributed the highest number of lives saved by burnthrough protection at 8 minutes (the longest time assessed), was in Kano on 22 January 1973. This accident contributed a median saving of 52 lives. If this accident is removed from the analysis the median number of lives saved per year reduces by 1.9, i.e., 5.7 reduces to 3.8. While this is a significant reduction,

the value still is just on the edge of the range assessed by this analysis prior to applying the correction factor of 1.84 as discussed in section 5.1 of this report. If information were available for all burnthrough accidents then the deletion of one accident would have less of an effect.

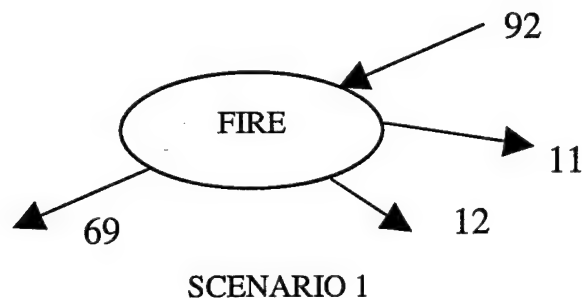
For Scenario 1, it is assessed that later requirements would have improved flammability standards such that the occupants would have had additional time to escape. It is assessed that 11 fatalities would have escaped with non-fatal injuries and further that 11 seriously injured would have escaped with minor or no injuries.

The survivability chain for Scenario 1 therefore becomes:

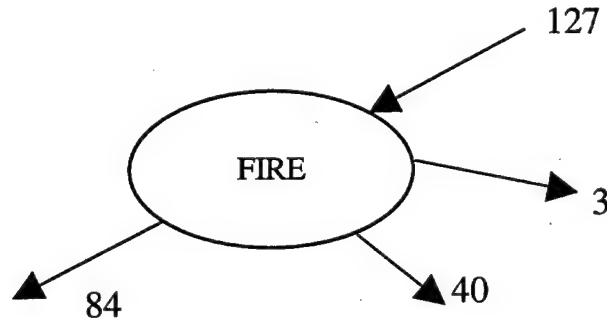
SCENARIO 1

For Scenario 1, it is assessed that later requirements would have improved flammability standards such that the occupants would have had additional time to escape. It is assessed that two of the fatalities would have escaped with non-fatal injuries.

The survivability chain for Scenario 1 therefore becomes:

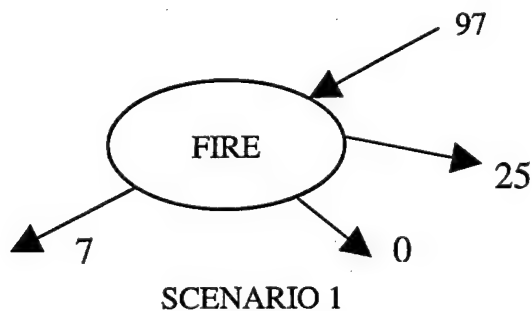
For Scenario 1, it is assessed that later requirements would have improved flammability standards such that the occupants would have had additional time to escape. It is assessed that an additional eight occupants would have successfully evacuated.

The survivability chain for Scenario 1 therefore becomes:

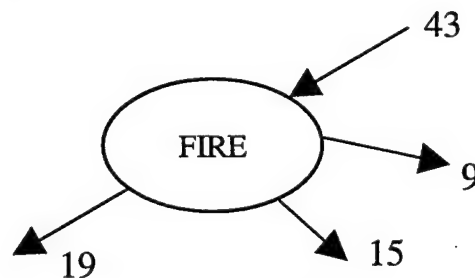
SCENARIO 2

Scenario 2 contains the main passenger cabin, which suffered internal fire and had only three of the seven exits available for egress. It includes all passengers and flight attendants. Smoke was very dense and hampered attempts to locate open exits.

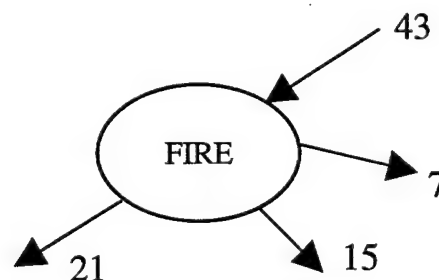
SCENARIO 2

For Scenario 2, it is assessed that floor proximity lighting would have enabled two of the nine fatalities to find an available exit, i.e., the two passengers found in the cockpit who walked past the open main entry door.

The survivability chain for Scenario 2 therefore becomes:

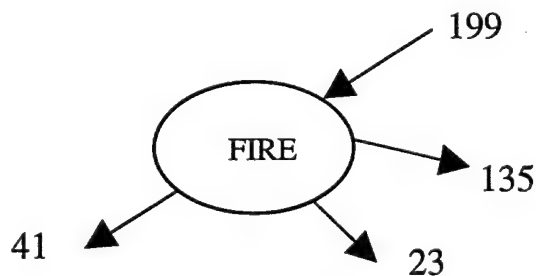
SCENARIO 2

For Scenario 2, it is assessed that later requirements would have improved flammability standards such that the occupants would have had additional time to escape. It is assessed that an additional 41 occupants would have evacuated and 41 of the seriously injured would have escaped with minor or no injuries.

The survivability chain for Scenario 2 therefore becomes:

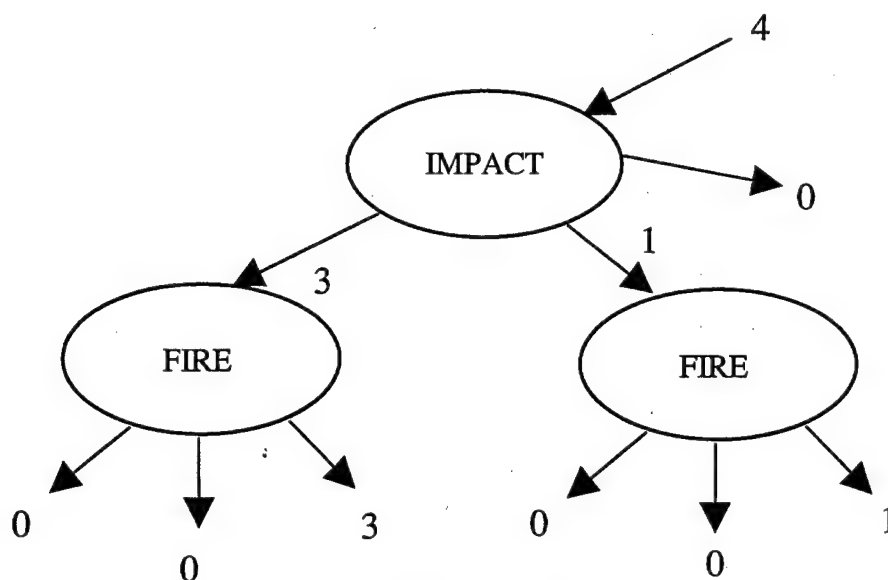
SCENARIO 1

Scenario 1 contains the flight deck area. It was subjected to the initial impact which was not severe but did create a hole in the forward skin that the third officer used to crawl out from and escape. The scenario contains the four flight crew.

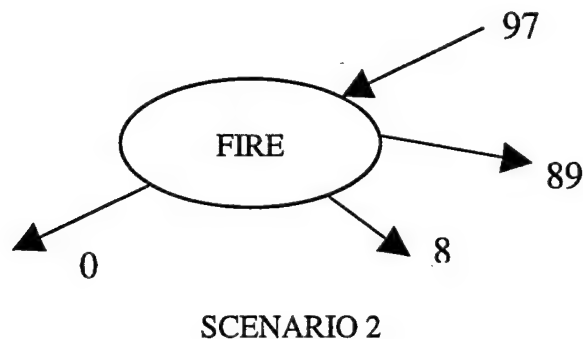
For Scenario 2, it is assessed that many were injured outside the aircraft in the external fire and hence later requirements would have only had a modest effect.

The survivability chain for Scenario 2 therefore becomes:

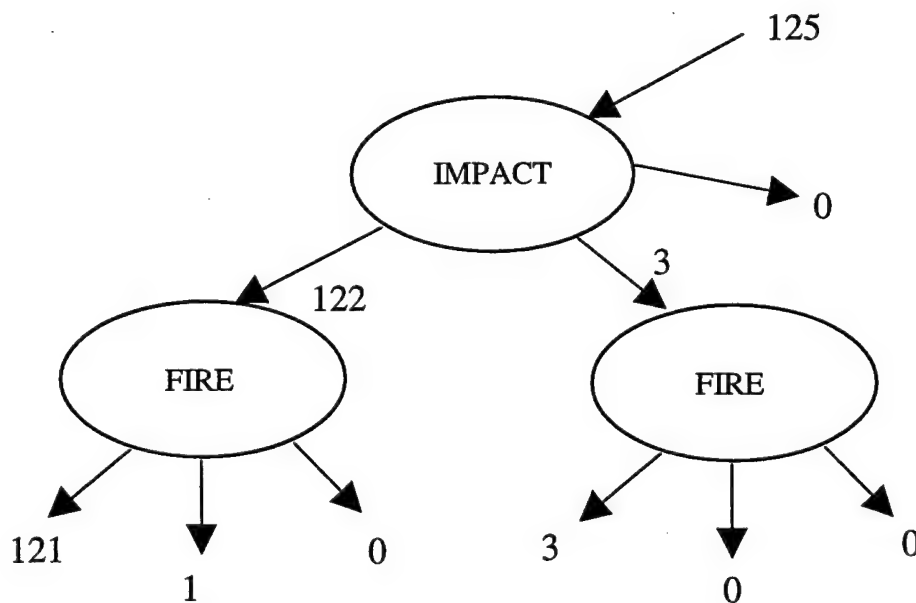
SCENARIO 3

For Scenario 3, it is assessed that later requirements would have provided additional time to escape for the only occupant injured by the fire. In this event it is assessed that the injuries would have been less severe and therefore not fatal.

The survivability chain for Scenario 3 therefore becomes:

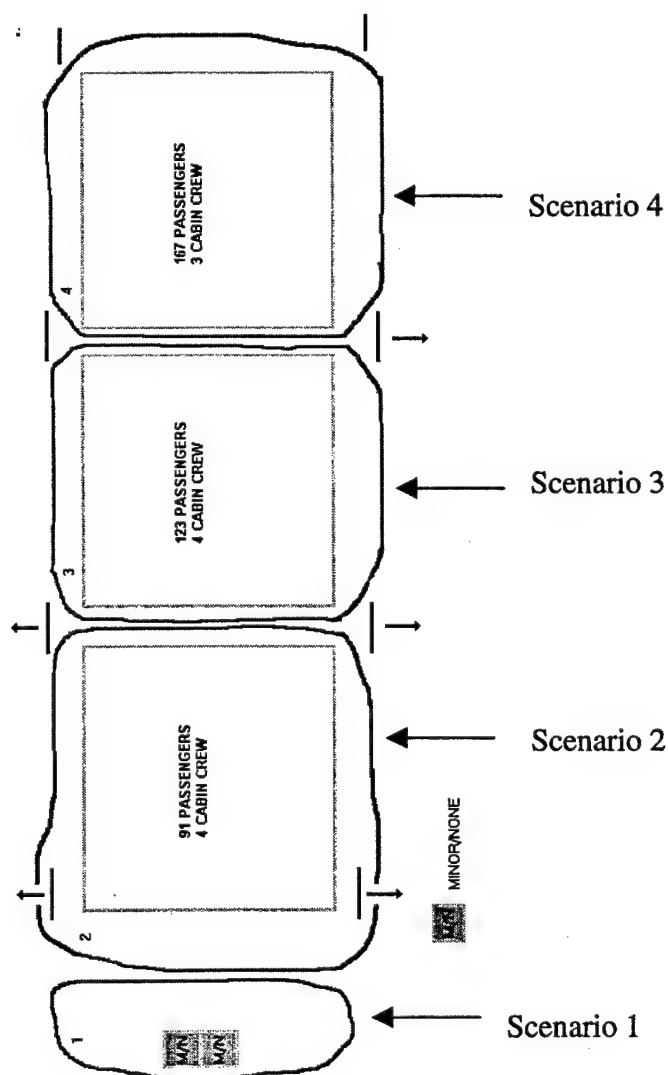
3. Location of Injuries and Scenarios

that flames from the smaller fire were being directed onto the fuselage side at the rear of the cabin and would have caused a burnthrough from the left side.

In addition, smoke was seeping in through a tear in the upper part of the passenger cabin at the height of door 4R. It is assessed, however, that there was no immediate burnthrough in this area.

Based on the above it is assessed that the prime burnthrough route was through the fuselage skin at the rear on the left side. However there was insufficient information to be conclusive about detail burnthrough areas.

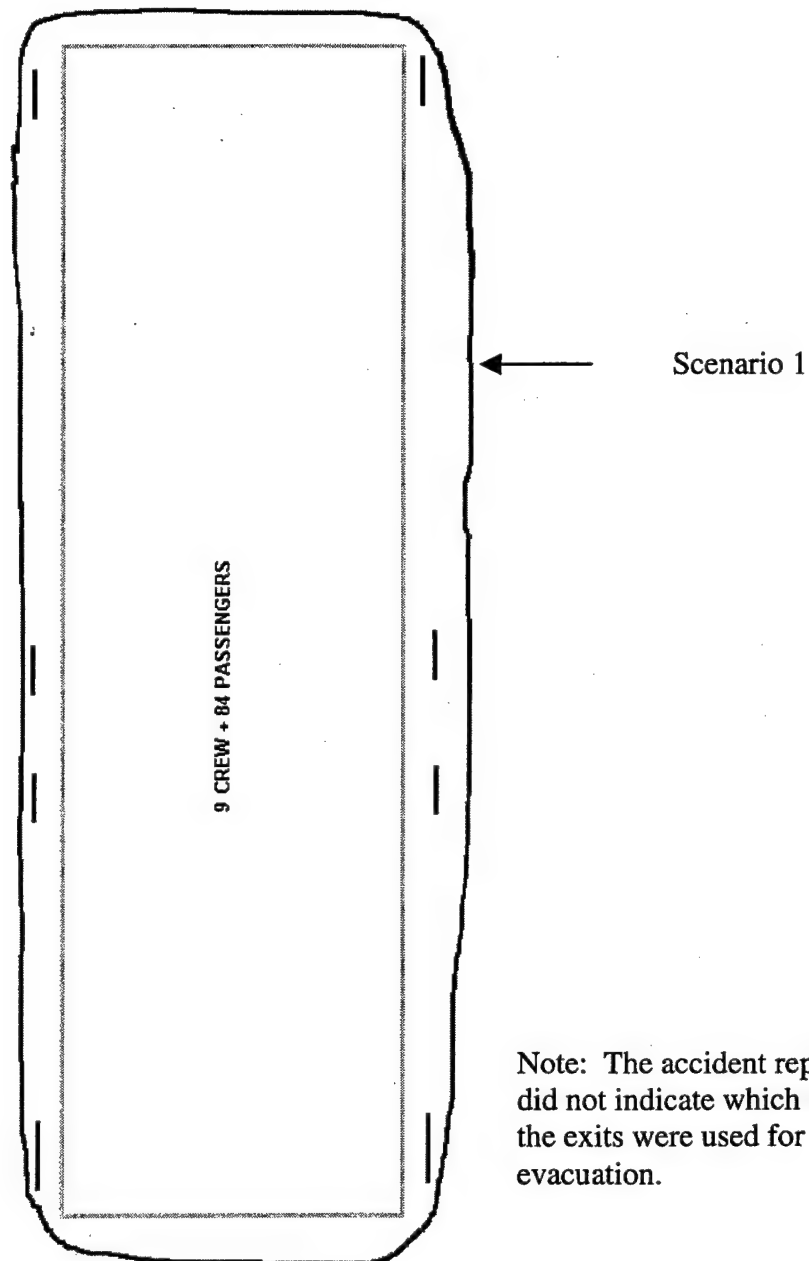
3. Location of Injuries and Scenarios

Fire broke out on the initial impact due to the breaking off of the port wing and the consequent leakage of fuel. The fire was instantaneous and on the port side of the aircraft. The fire and the smoke generated affected the passengers throughout the seconds which passed from when the collision occurred until the aircraft came to a complete stop and its evacuation.

It is assessed that some fire and smoke could have entered the cabin through ruptures in the fuselage side caused by the impact. In addition, there was a pool fire around the aircraft as it came to a stop and it is assumed that this fire would have burnt through the fuselage during the evacuation.

Based on the above it is assessed that the prime burnthrough route was through the fuselage skin. However there was insufficient information to be conclusive about detail burnthrough areas. It is additionally assessed that fire could have also entered the fuselage through ruptures.

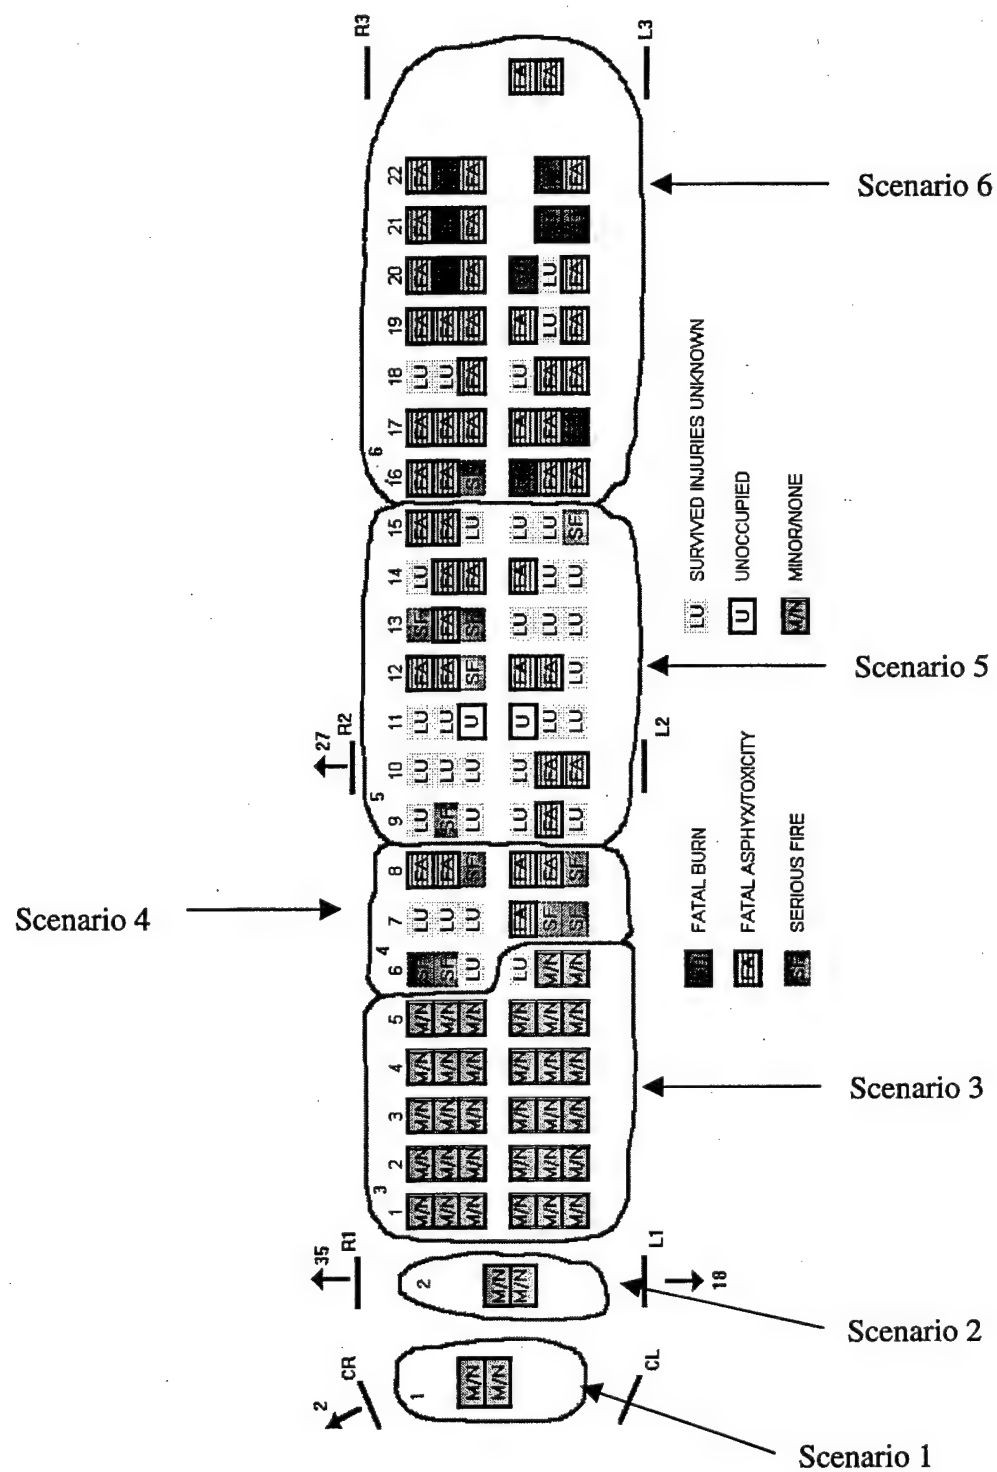
3. Location of Injuries and Scenarios

The rear fuselage was extensively burnt between the wing trailing edge and the rear doors; a large part of the left fuselage side between frames 787 and 887 (approximately seat rows 17 to 21) was completely burnt away. The whole of the fuselage aft of the rear cargo door and the tail section had collapsed onto the ground.

Analysis of the wreckage has shown that the fire initially penetrated the skins on the left side in the vicinity of seat rows 17 to 19, below the level of the cabin floor. Having breached the outer skin, the only barrier which prevented the fire gaining access to the cavity formed between the outer skin and the cargo bay side-liner panels, which communicated directly with the cabin interior above via floor level air-conditioning grills, was a 1 inch thick fibreglass wool acoustic insulation blanket contained in a thin plastic bag.

Based on the above, it is assessed that the prime burnthrough route was through the fuselage skin and windows on the left side.

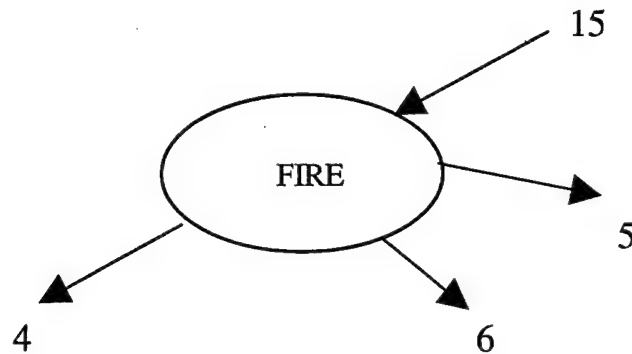
SCENARIO 4

Scenario 4 contains the front section of the passenger cabin from seat row 7 to seat row 8 inclusive and the right side of row 6. Occupants in this area made their way to the L1 and R1 exits. Those further from the exits had a longer exposure to the fire and smoke and were either injured or asphyxiated. It is assumed that the unknown injuries were minor.

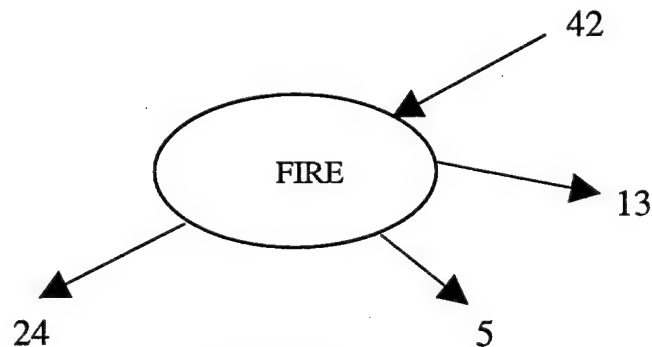
SCENARIO 5

Scenario 5 contains the midsection of the passenger cabin from seat row 9 to seat row 15 inclusive. This area had only the R2 overwing exit open and useable. Those occupants closest to the exits executed a successful evacuation. Those further away had a longer exposure to the fire smoke and were either injured by fire or overcome by smoke and toxic gas. It is assumed that the unknown injuries were minor. The numbers include two infants who were carried out of the aircraft uninjured.

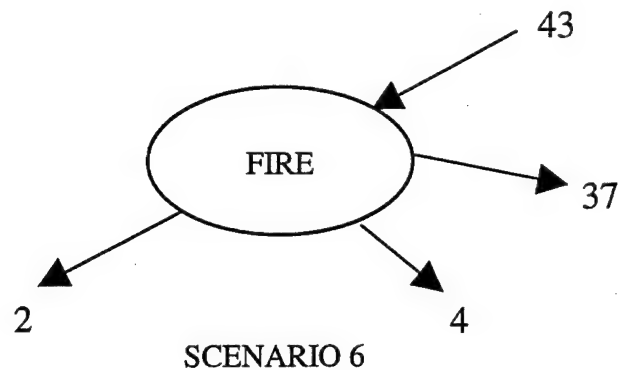
Scenario 6 contains the rear section of the passenger cabin from seat row 15 to seat row 22 inclusive as well as the two rear flight attendants. This area had only the R2 overwing exit open and useable and was the area in which the fire burnt through and entered the cabin. All occupants from this section had a significant distance to travel before reaching the overwing exit. Further, visibility was severely restricted by dense black smoke and location of exits was almost impossible. As a result, most of the occupants either died as a result of burns or were overcome by the smoke and toxic gas. It is assumed that the three unknown injuries next to the point of fire entry were serious and all other unknown injuries were minor. The numbers include an infant who was asphyxiated in the cabin.

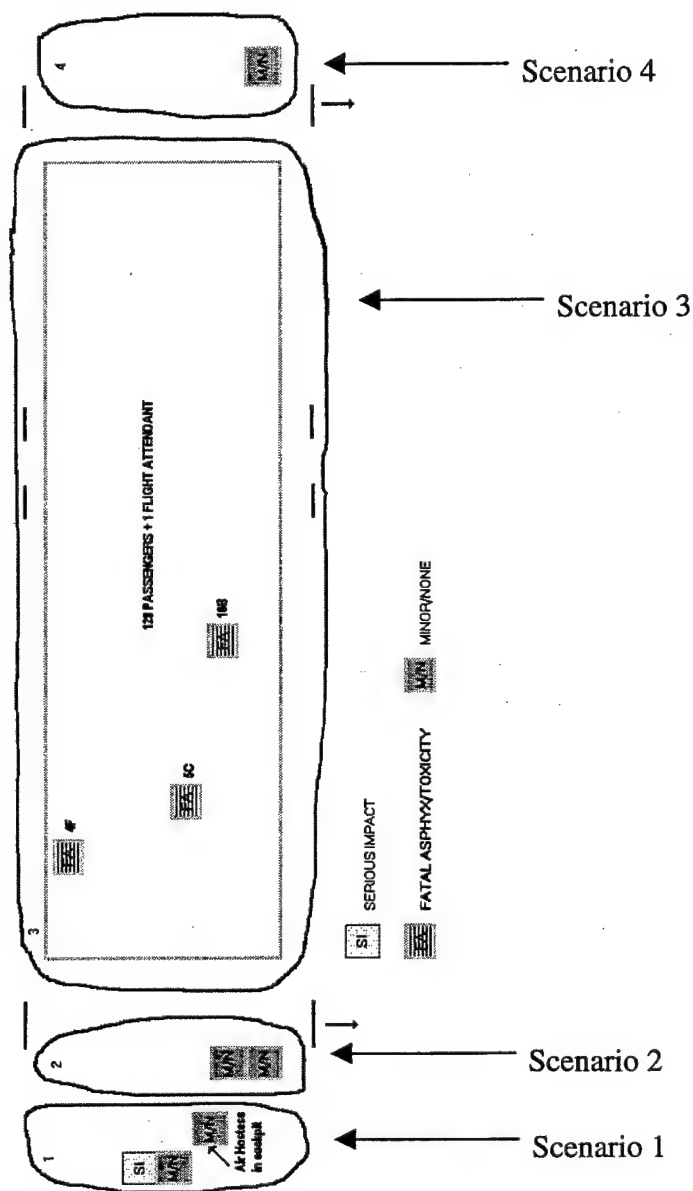
3. Location of Injuries and Scenarios

Based on the above it is assessed that the prime burnthrough route was through the fuselage skin on the right side. However there was insufficient information to be conclusive about detailed burnthrough areas.

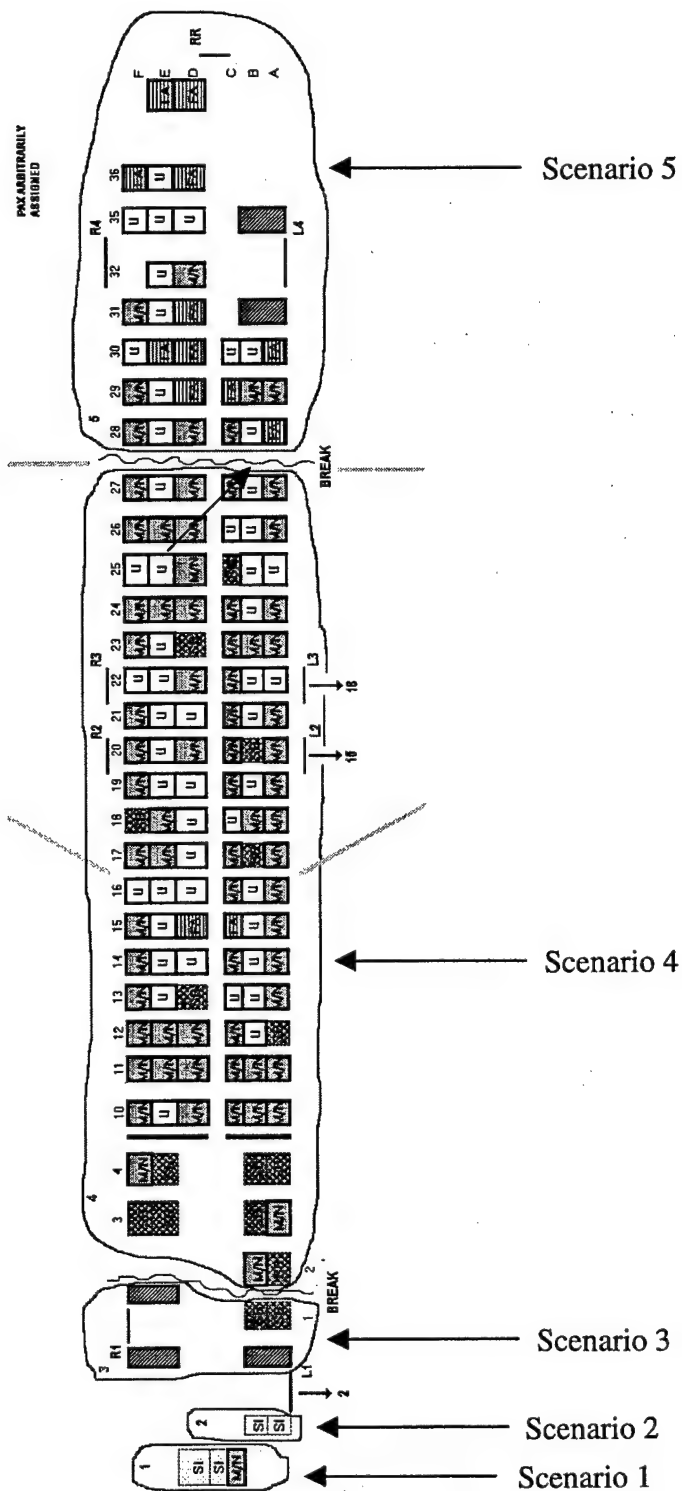
3. Location of Injuries and Scenarios

Based on the above it is assessed that the prime burnthrough route was in the midsection lower fuselage skin in the wing box area. However there was insufficient information to be conclusive about detail burnthrough areas.

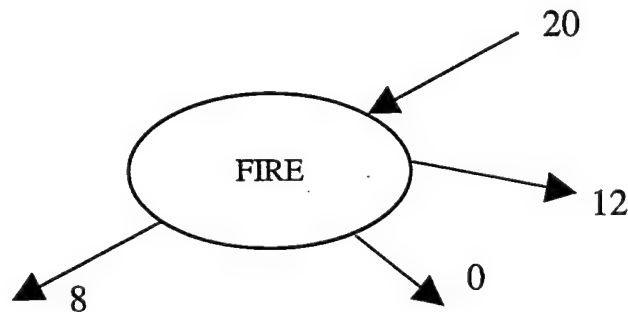
SCENARIO 5

Scenario 5 contains the passenger cabin from the rear fuselage break at seat row 28 to the rear of the cabin. All injuries were sustained from the postcrash fire which entered the cabin by burning through the cabin floor from the cargo area where the cargo door had been torn off. All survivors exited through fuselage breaks.

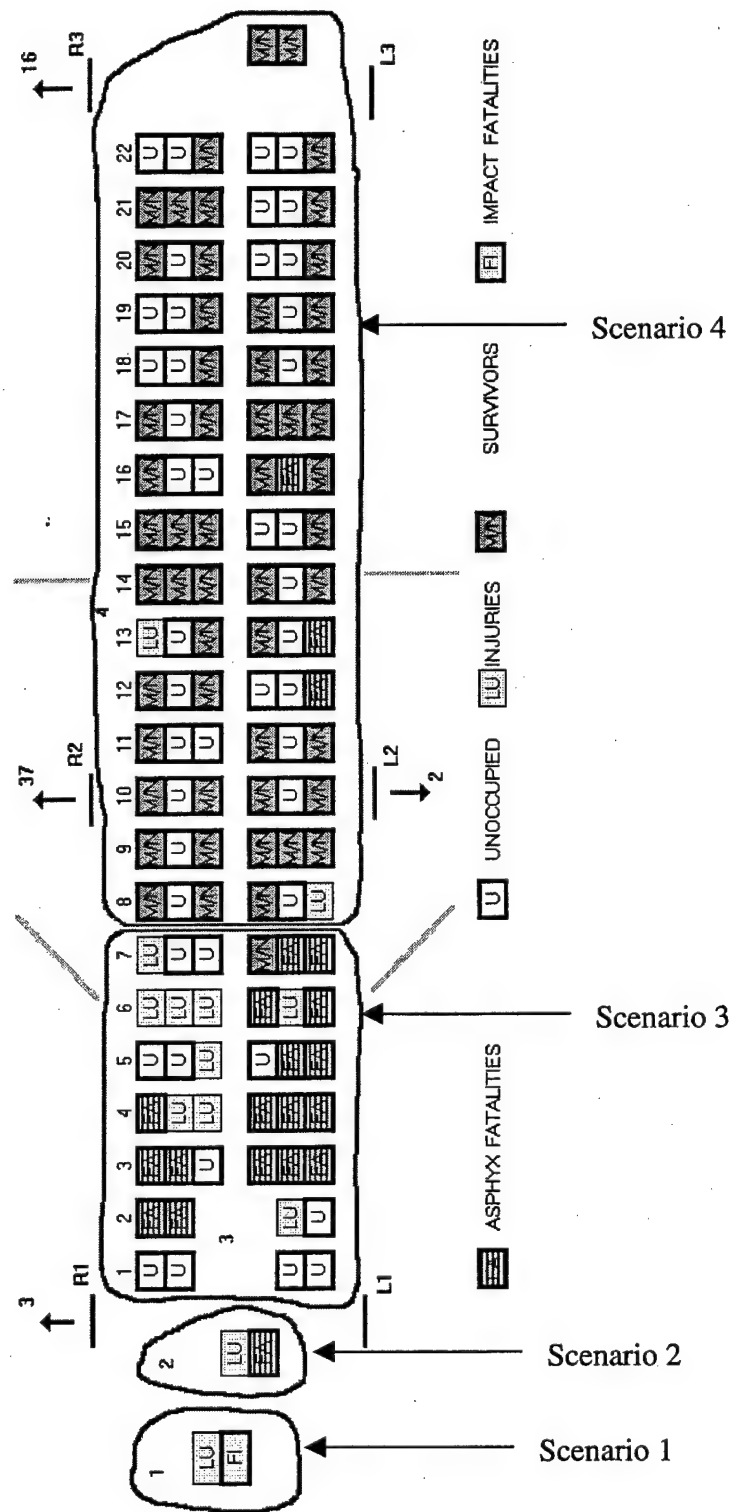
3. Location of Injuries and Scenarios

Based on the above, it is assessed that the prime burnthrough route was through the fuselage lower skin; however, more significant, non-burnthrough fire entry paths were also present.

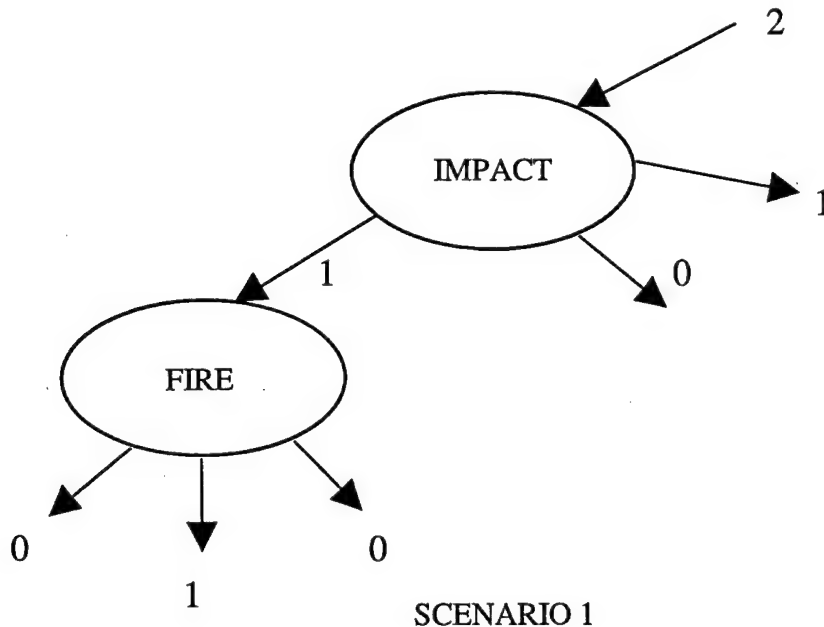
Scenario 1 contains the flight deck area. It was subjected to substantial impact damage as the aircraft impacted the fire station building and was crushed. The captain sustained multiple traumatic injuries. The unknown injury was assumed to be serious and as a result of the fire.

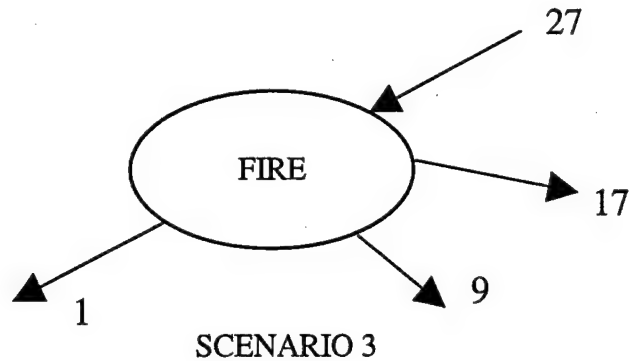
Scenario 3 contains the passenger cabin from seat row 1 in first class to row 7 in the coach section inclusive. This was subjected to dense smoke and fire and R1 & R2 were the only usable exits. It can be assumed that the smoke hindered the occupants' attempts at locating the exits

and as a result many were overcome. This scenario contains 27 passengers. The unknown injuries were assumed to be serious and as a result of the fire.

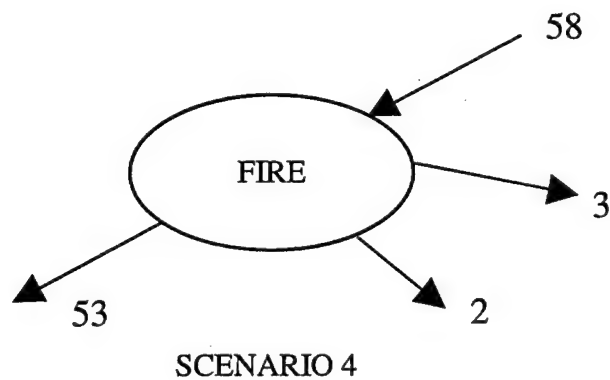
Scenario 4 contains the passenger cabin from seat rows 8 to the rear of the cabin, including the aft cabin attendant area. This area had the longest time before smoke and fire hampered evacuation. R2, L2, and R3 exits were available for egress. The scenario contains 56 passengers and 2 flight attendants. The unknown injuries were assumed to be serious and as a result of the fire.

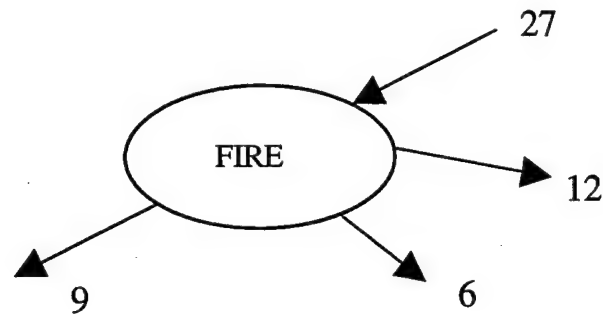
SCENARIO 3

Additional time would be provided to facilitate escape if the aircraft had been configured to these improved flammability standards. Furthermore improved access to Type III exits is likely to have relieved the congestion at the overwing exit. However, due to the intensity of the fire, which was most probably increased in severity by the release of oxygen, the reduction in fatalities resulting from these improvements would have been modest.

The survivability chain for Scenarios 1 and 2 are therefore unchanged, and Scenarios 3 and 4 become:

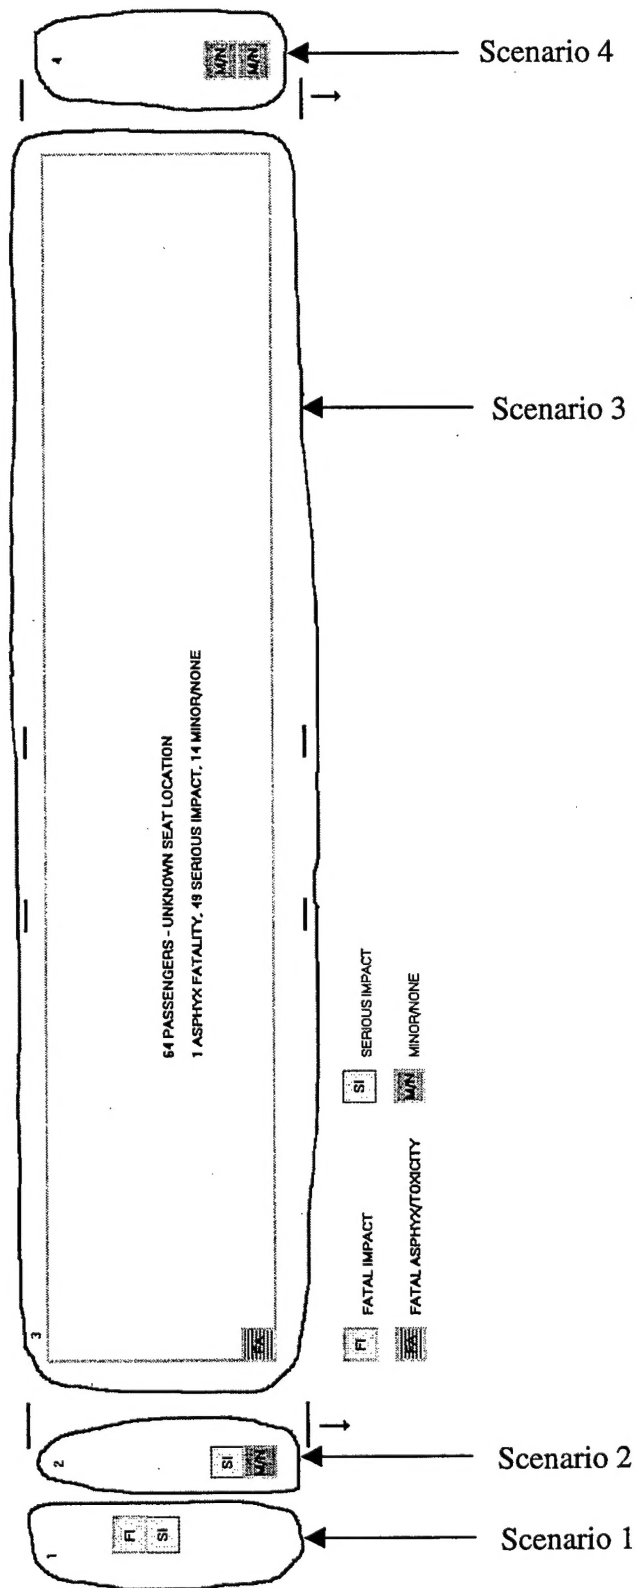
3. Location of Injuries and Scenarios

The passenger seated in the utmost left seat in "business class" sustained a fracture of the first lumbar vertebra and of both hands. This made him probably unable to leave his seat unaided. In addition, his temporary loss of consciousness during the impact did not allow him to draw the attention of other passengers and cabin attendants.

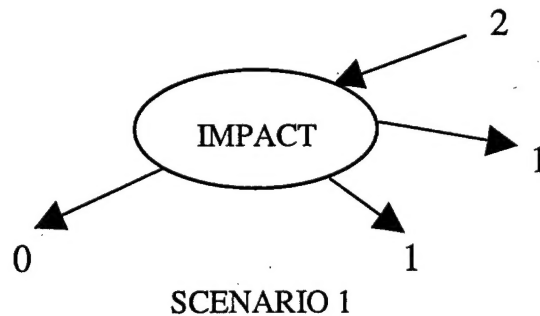
Scenario 1 contains the flight deck area where all injuries were sustained from the impact. The scenario contains the two flight crew.

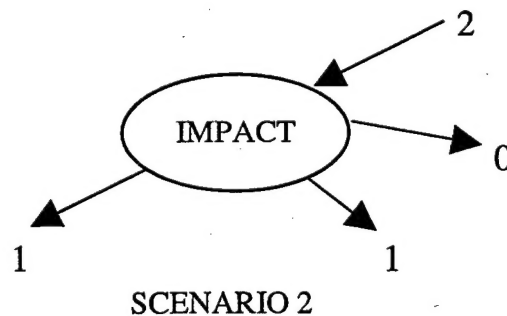
Scenario 2 contains the forward flight attendant area where injuries were sustained from the impact. The scenario contains two flight attendants.

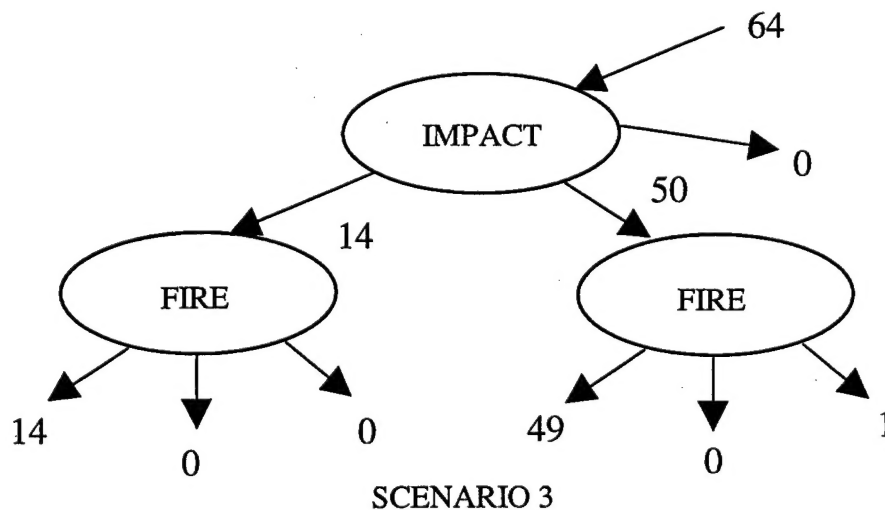
Scenario 3 contains the whole passenger cabin. This has been used because of limited detail on passenger locations during the accident. The scenario contains all 64 passengers.

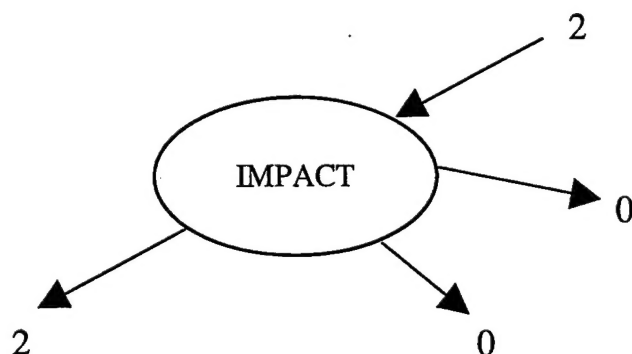
SCENARIO 4

Scenario 4 contains the rear flight attendant area where only minor injuries were sustained from the impact. The scenario contains two flight attendants.
